6. Rehabilitation Implementation

REHABILITATION MANAGEMENT PLAN Report No. 117/62

TRITTON RESOURCES PTY LTD ML1280, MPL294, MPL295 – Murrawombie Copper Mine

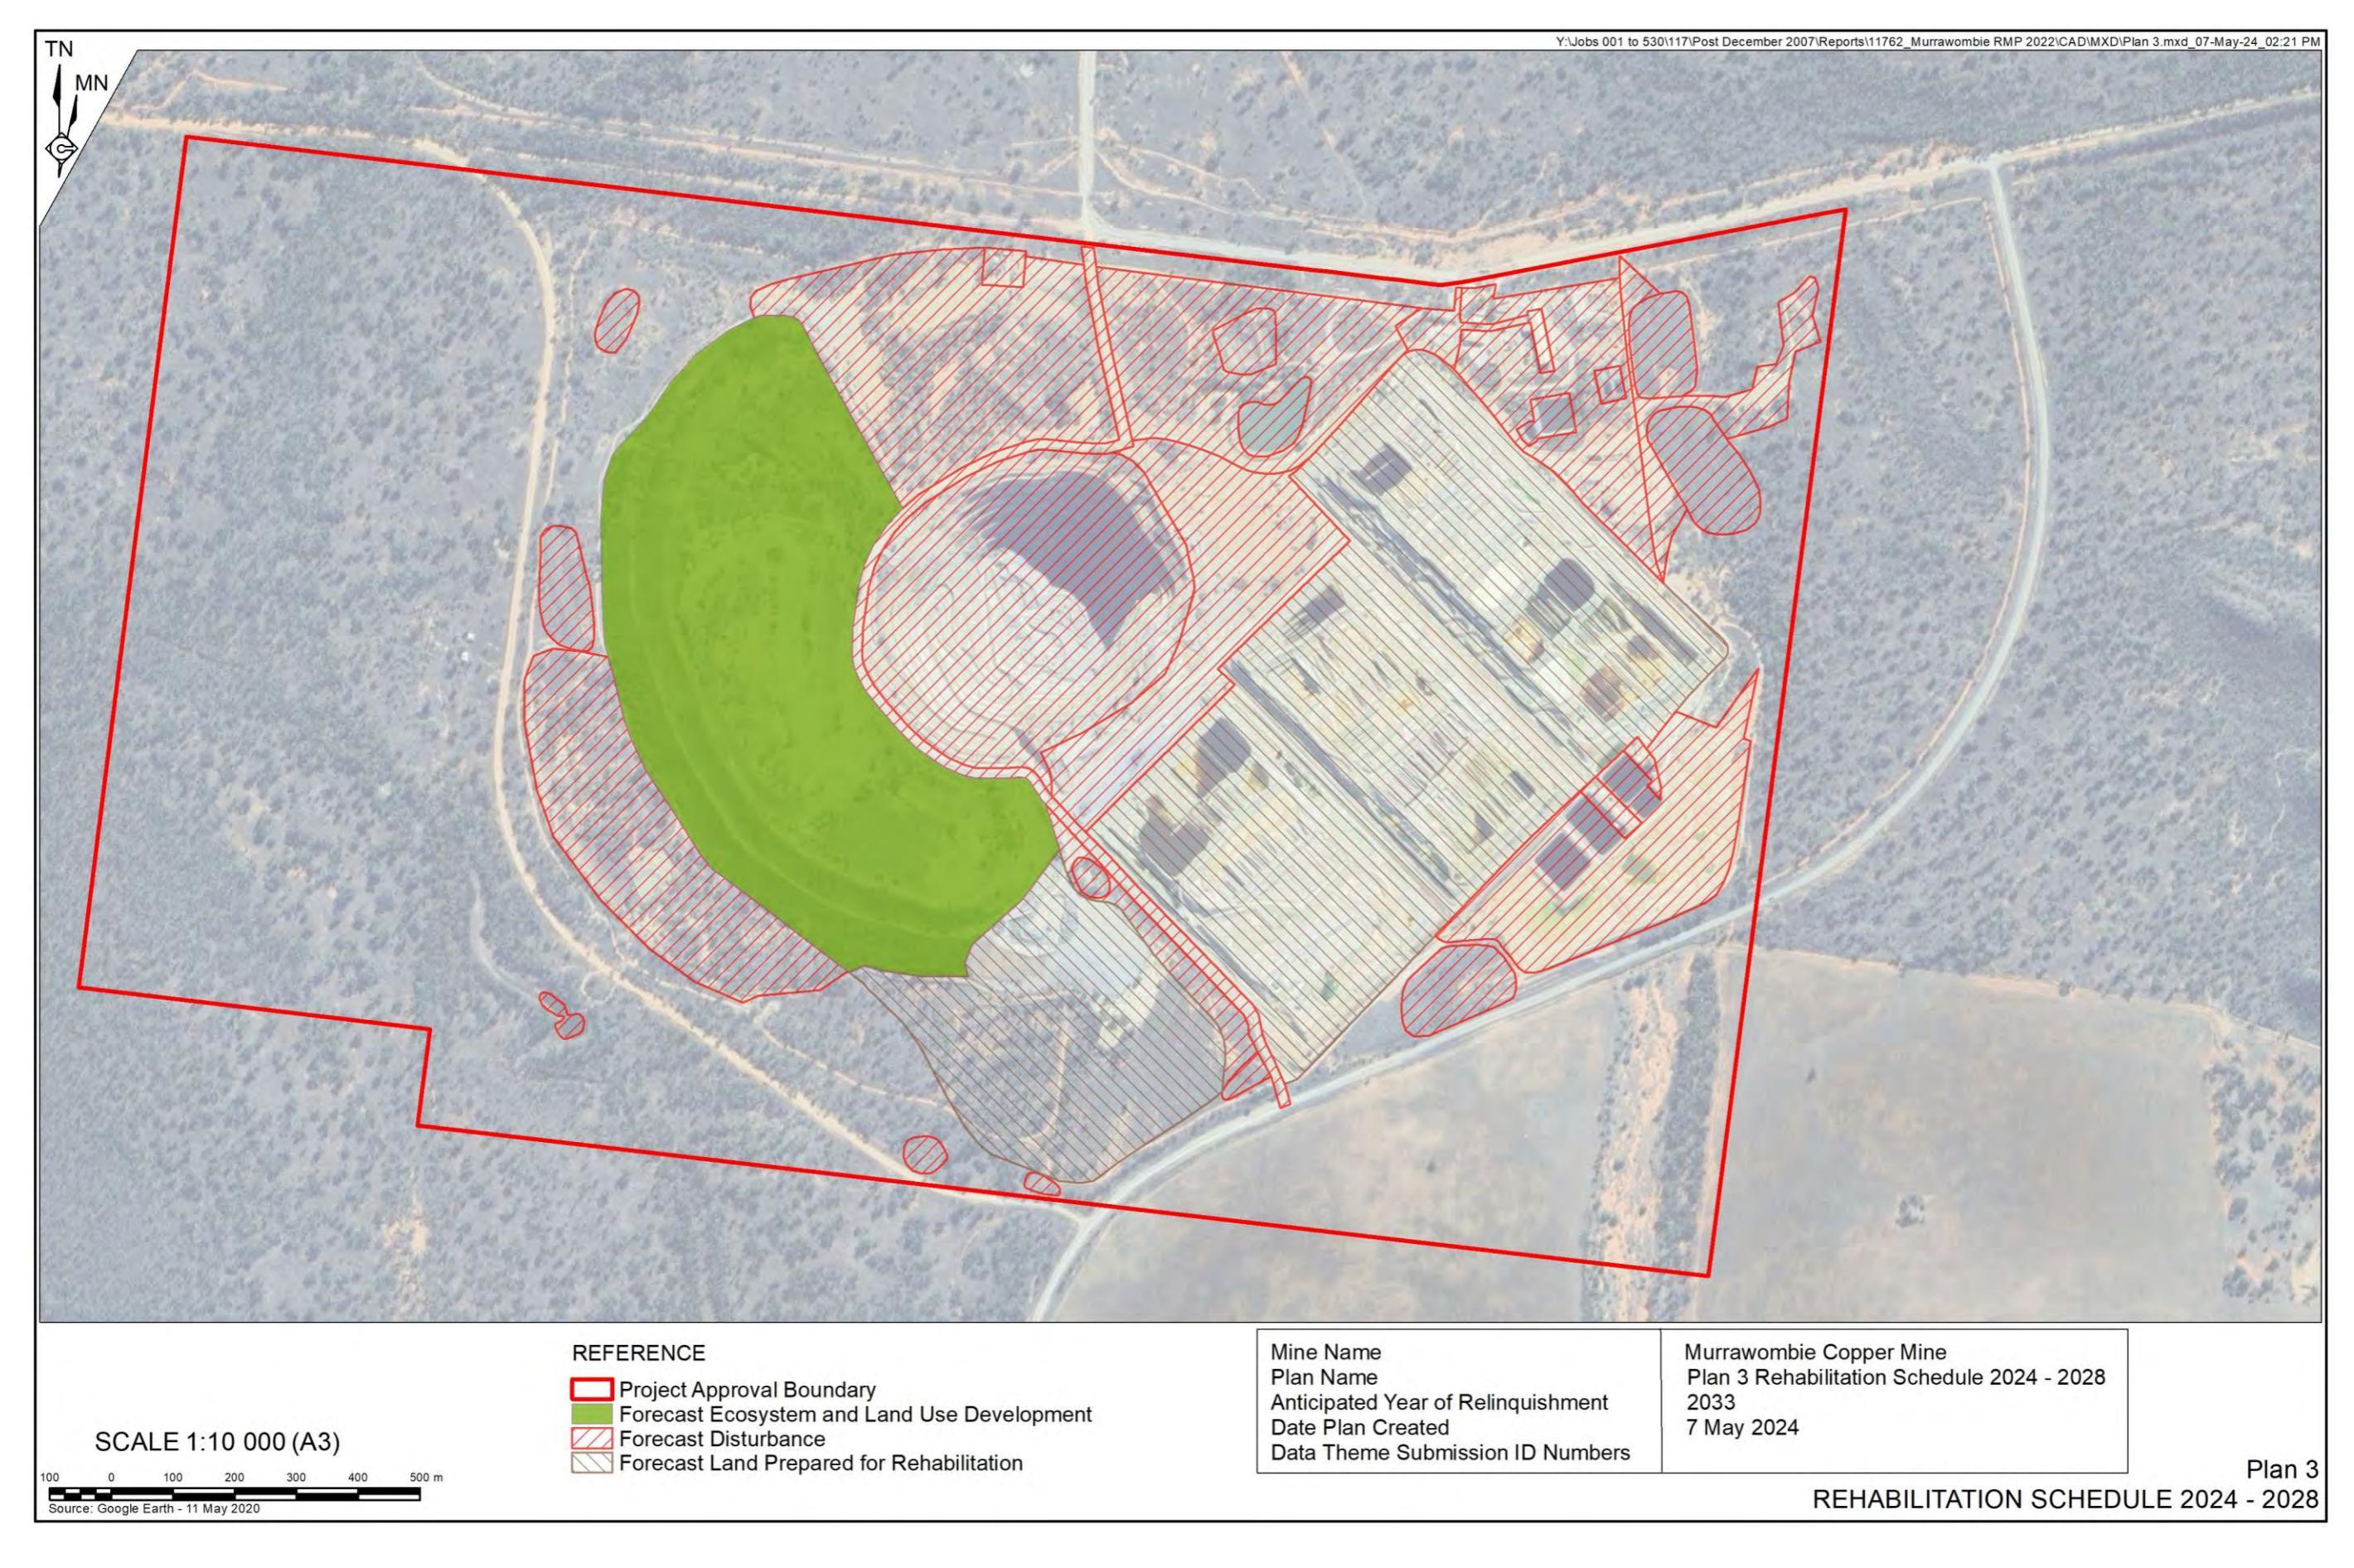
The rehabilitation schedule for the Mine, as presented on **Plan 3** and **Plan 4**, is summarised as follows.

- 2024 to 2028 (**Plan 3**)
 - The Mine Site remains operational to support open cut mining.
 - Closure of the Heap Leach Pads continues using waste rock soured from the cutback.
 - Prior to completion of mining activities, undertake rehabilitation research and studies including detailed Heap Leach Pad cover design, drainage design for closure, modelling of final void behaviour and landform evolution modelling.
 - Landform establishment and growth medium development of the Murrawombie Waste Rock Emplacement, following completion of landform evolution modelling.

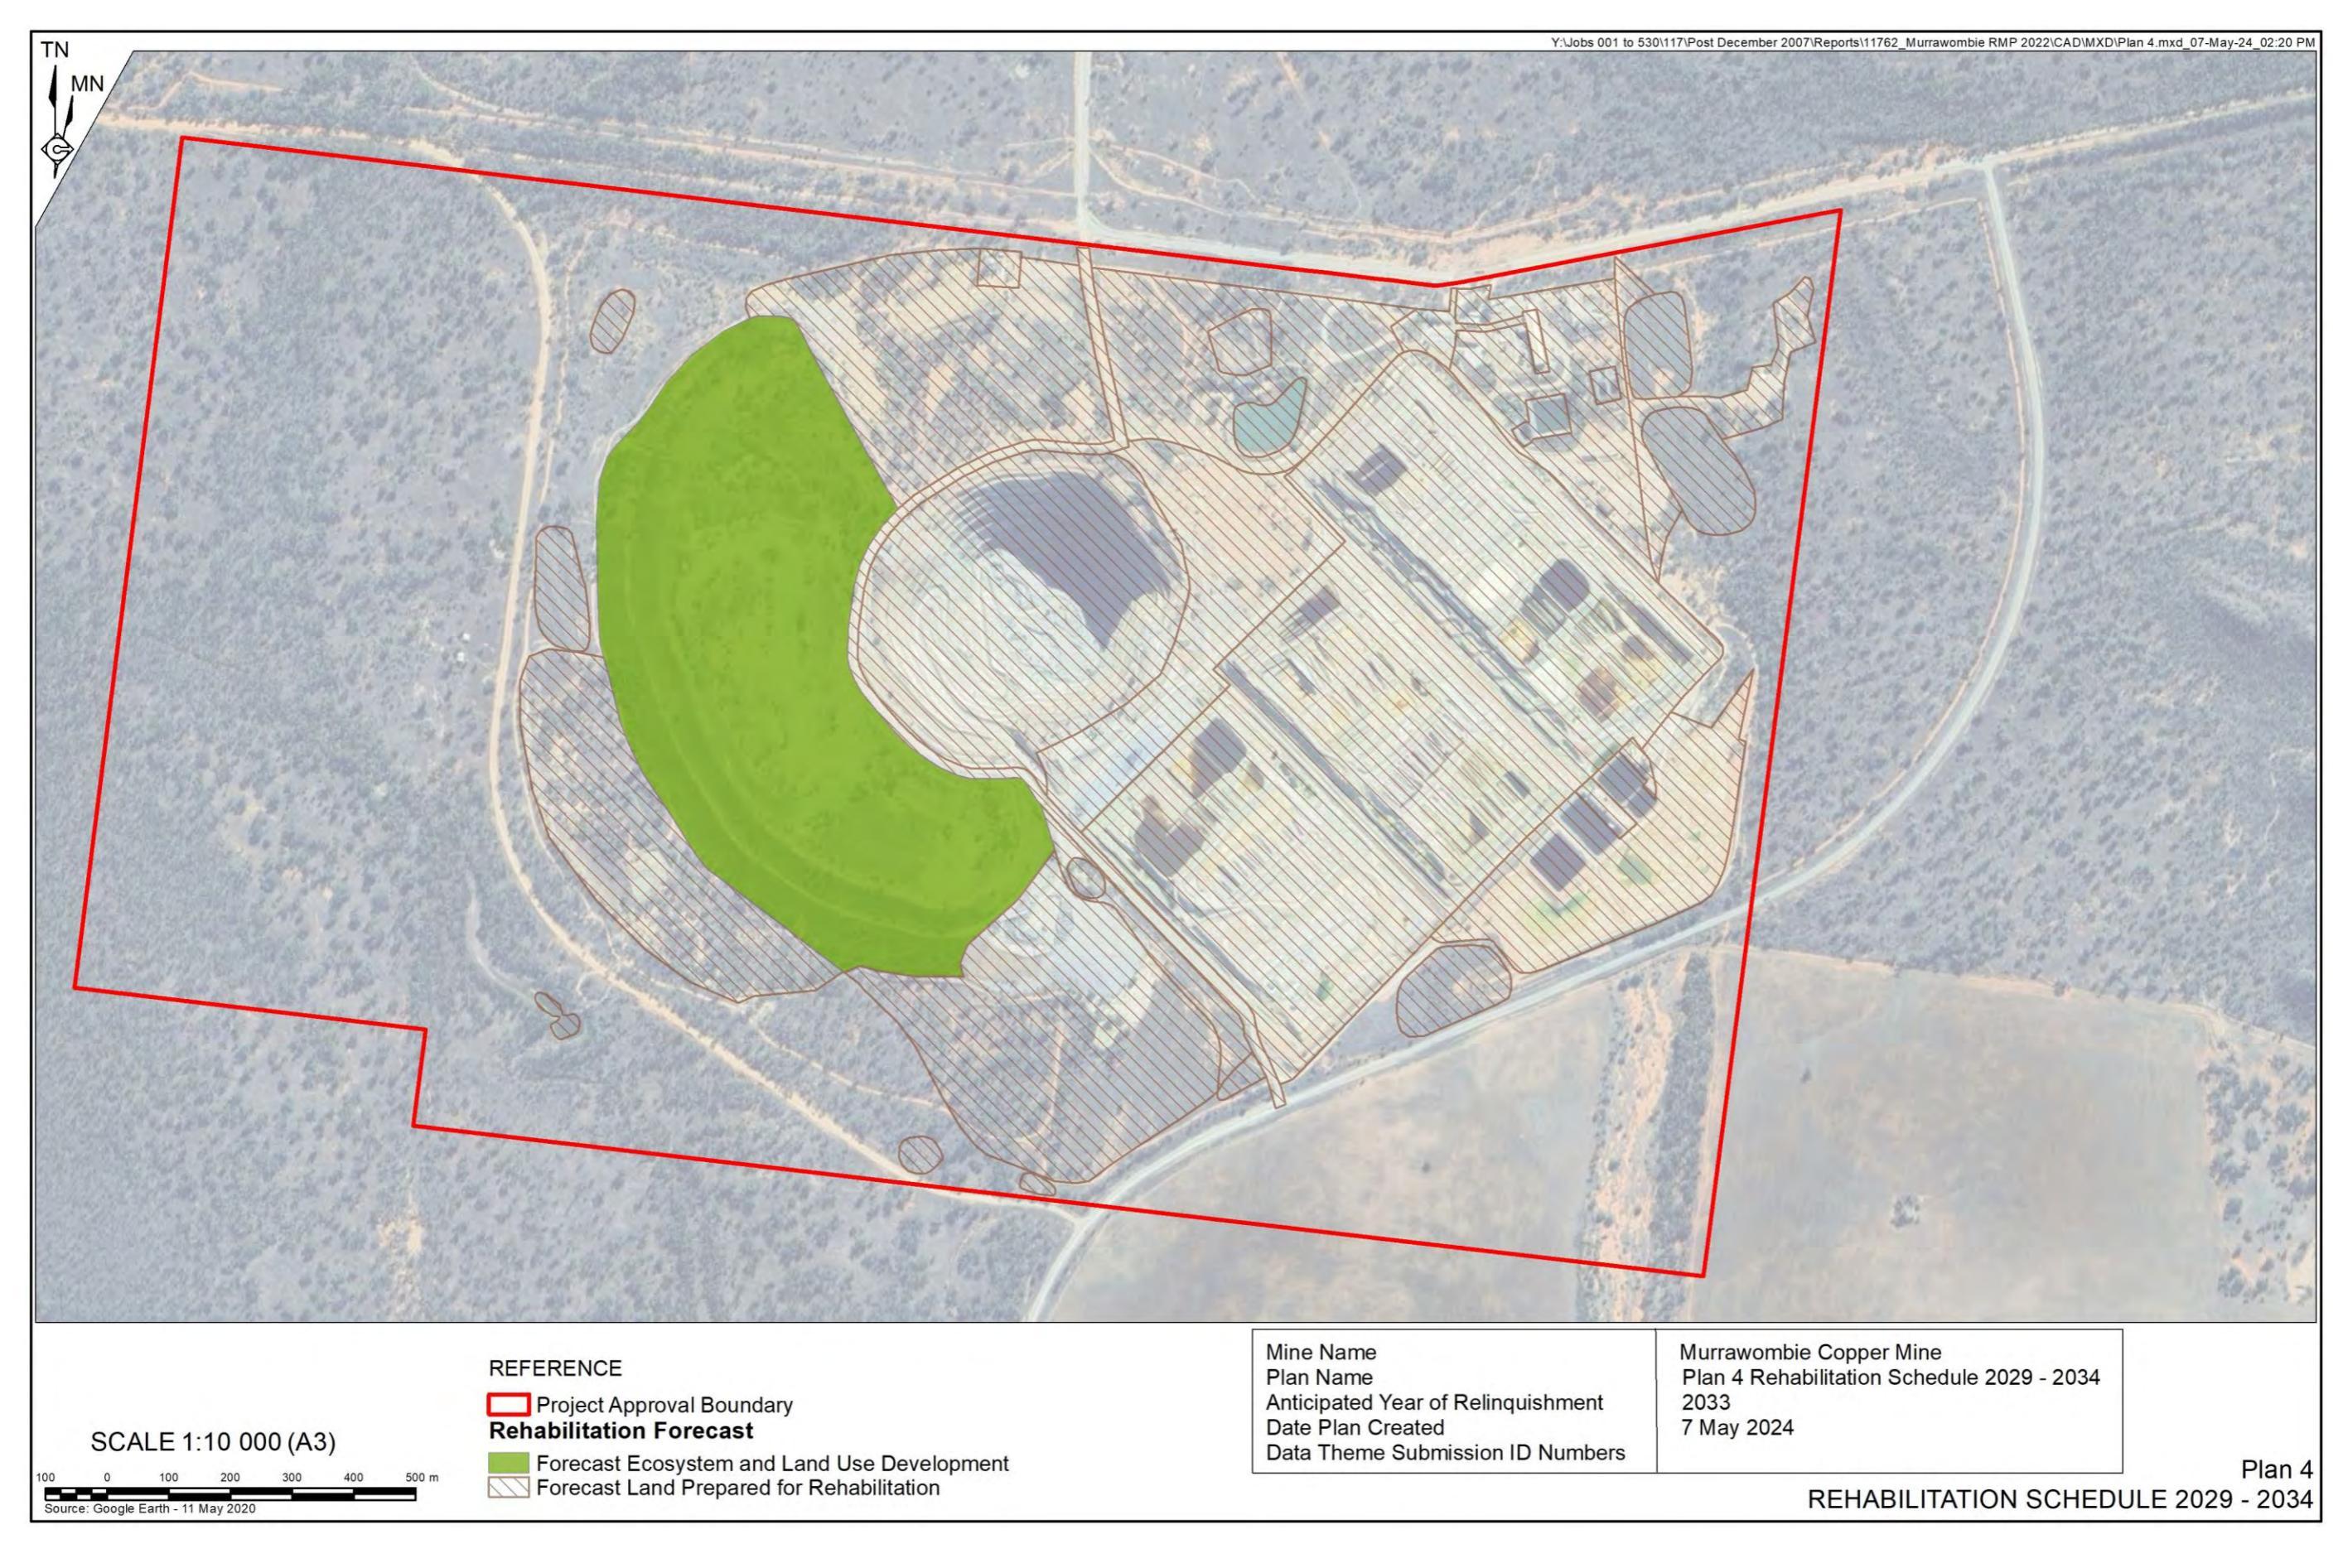
- 2029 to 2034 (**Plan 4**)
 - Whole of site decommissioning, landform establishment, growth medium development and ecosystem and land use establishment and developments phases of rehabilitation to occur across all mining domains.
- 2035 to 2040 (**Plan 5**)
 - It is anticipated that the rehabilitation of all mining domains and the successful establishment of all final land use domains (up to the Ecosystem and Land Use Establishment phase, as a minimum) will be completed by 2034 with a further seven years of monitoring and maintenance (to 2039).
